【BLK360のFW v2.1.0がリリースされ、BLK360とPCのケーブル接続に関する件】

Leica Geosystems Release Notes

Leica BLK360 Imaging Laser Scanner – Firmware v2.1.0

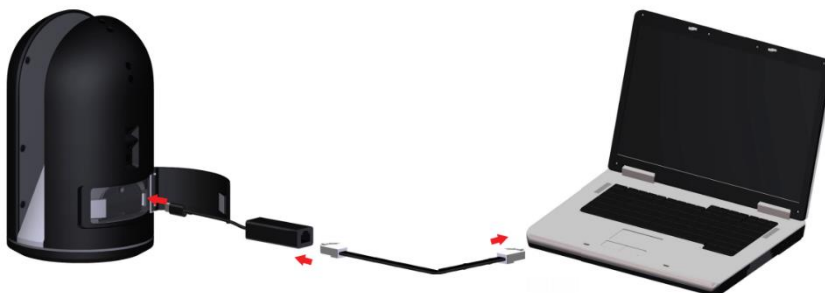
Configuration for a direct LAN communication

In case the computing device does not have an ethernet port, a 2nd USB-C to Gigabit-Ethernet adapter can be used.

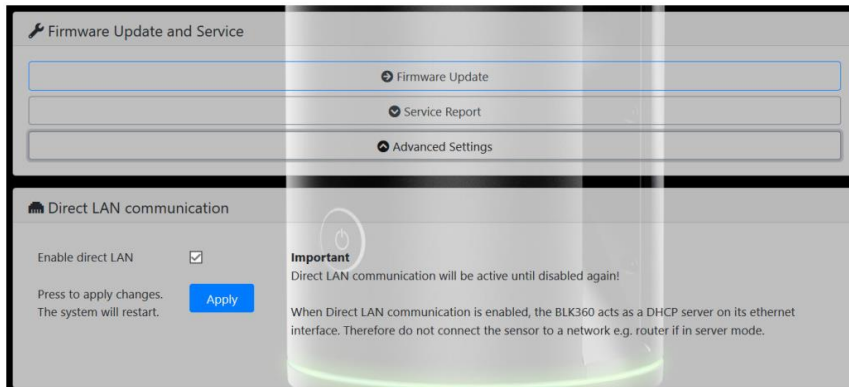
Set the tick-mark for “Enable direct LAN” and press Apply.

This will now enable a build-in DHCP Server. The direct LAN settings configures the Leica BLK360 as DHCP server, which provides an IP to the connected computing device.

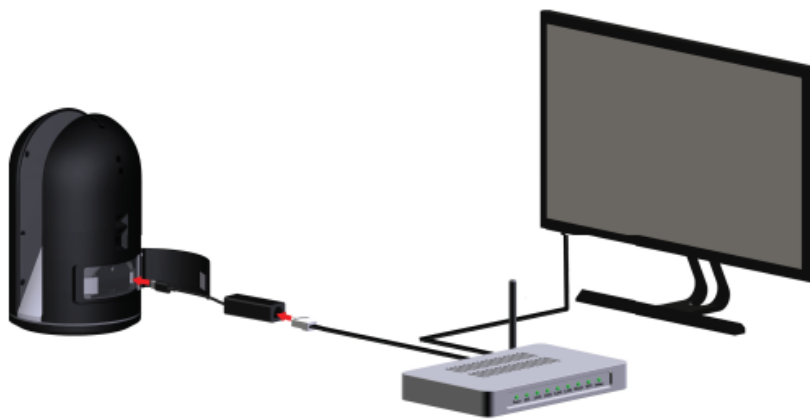
For this option the default configuration of the Leica BLK360 can be used. The Direct LAN setting in the webinterface must be disabled!

The direct LAN settings configures the Leica BLK360 as DHCP server, which provides an IP to the connected computing device. Since the IT network usually provides an IP to the connected devices (in this case the Leica BLK360) this could cause issues in the network.

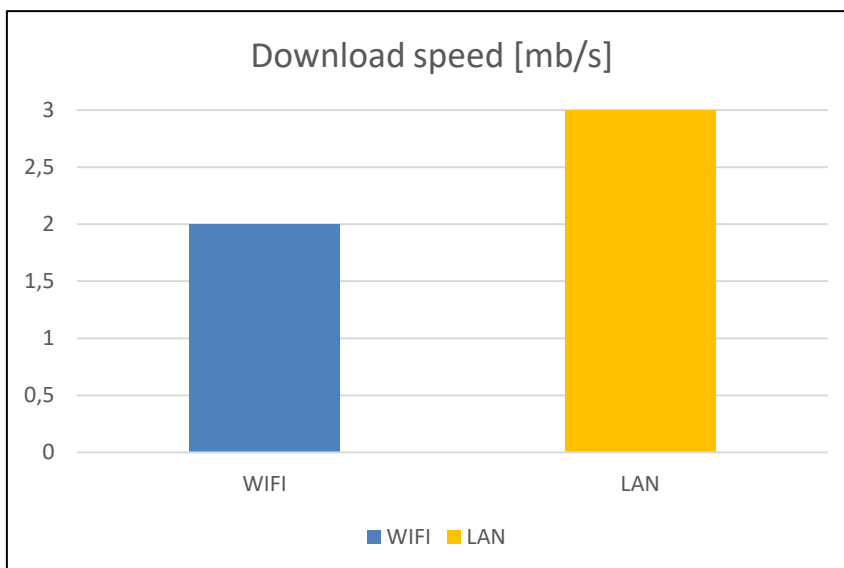
Improved data transfer speed using LAN communication

The download speed using a LAN communication is in general 50% faster than using WiFi. This is valid for direct data transfer to a computing device and using a LAN network structure.

The speed of the data transfer not only depends on the used method (WiFi or LAN) but changes as well with the used computing device. For the setup using a LAN infrastructure (router) other factors will affect the speed as well. For example the general traffic within the network.
