【BLK360のFW v2.1.0がリリースされ、BLK360とPCのケーブル接続に関する件】

Leica Geosystems Release Notes

Leica BLK360 Imaging Laser Scanner – Firmware v2.1.0

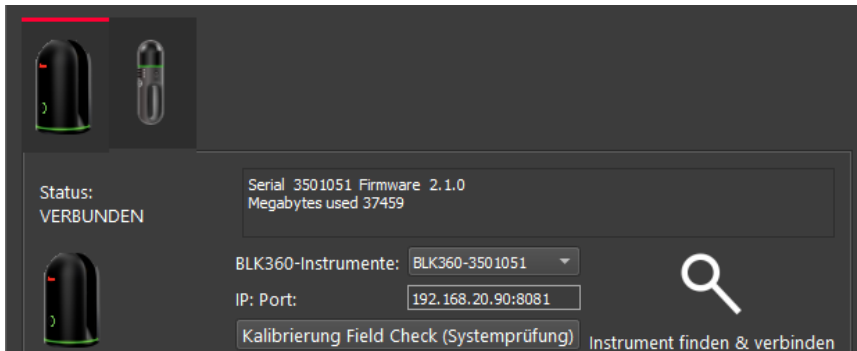
The maximum length of the Ethernet cable including the USB-C connector(s) must not exceed 3 meters.

To connect to the Leica BLK360 using a LAN connection, install the latest available apps of Cyclone Data Manager respectively Leica Cyclone Register 360/ Cyclone Register 360 BLK Edition. Older version do not support the LAN cable feature.
